RE: Heritage Masonry – 2nd Opinion - DRAFT
38 Main Street East, Almonte, Ontario

RJC No. TOR.137672.0001

1.0 INTRODUCTION

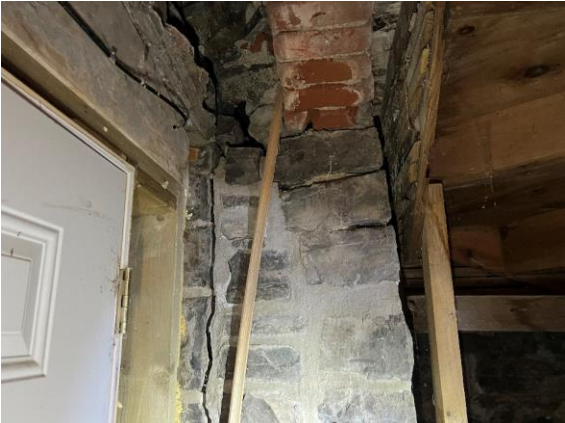
The Belltower showed signs of previous repair and subsequent localized deterioration. The interior of the Belltower base showed signs of cracking at the interior southwest corner (Refer to Photos 1 and 2).

Photo 1: Separation between Inner and Outer Wythe

The Belltower is in very poor condition, namely the southwest corner adjacent grade and the southeast corner at the top of the Belltower and requires immediate intervention. Water is infiltrating the tower and has damaged the core, joints and stone of the structure. The joints and core are in very poor condition. There is translation in the exterior wythe and stone. Cracking was noted through the interior of the Belltower. If left unattended, deterioration is expected to continue at an accelerated rate. As proposed in the 2023 Belltower Letter by John G. Cooke and Associates Ltd., RJC agrees that immediate intervention is required, before winter.

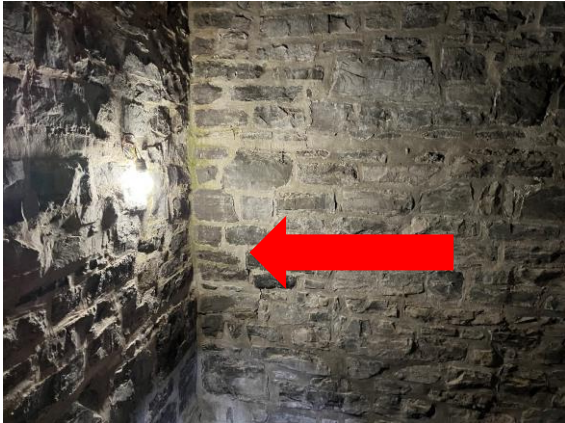
Photo 2: Cracking in Interior Wythe

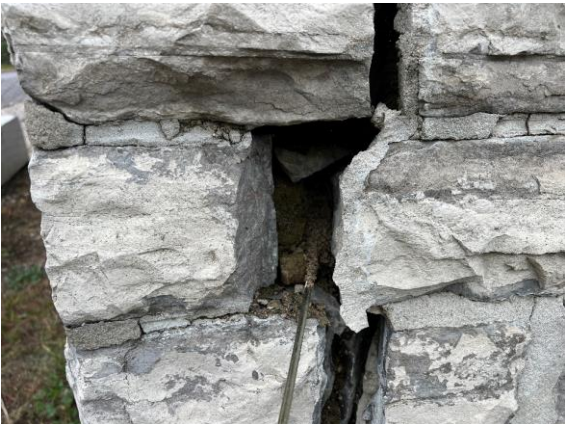
At the southwest corner of the belltower, the core was easily raked and consisted of soft sandy material (Refer to Photos 3 and 4). Large cracking was observed, with the wall bowing in southwest corner of Belltower (Refer to Photos 5 and 6).

Photo 3: Core Being Raked Out

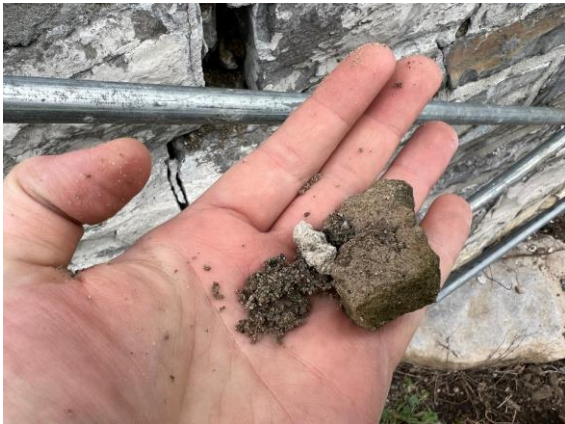
Photo 4: Soft Sandy Core

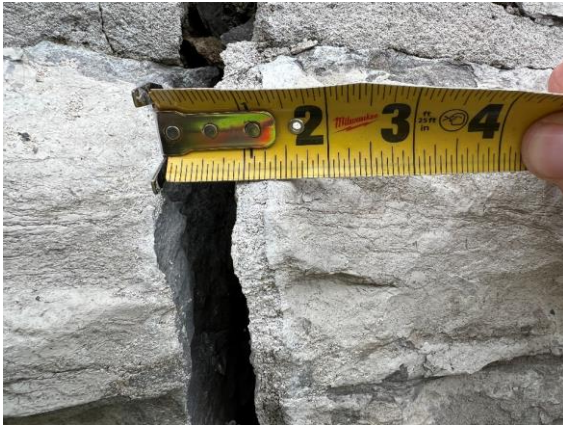
Photo 5: Large Vertical Cracking

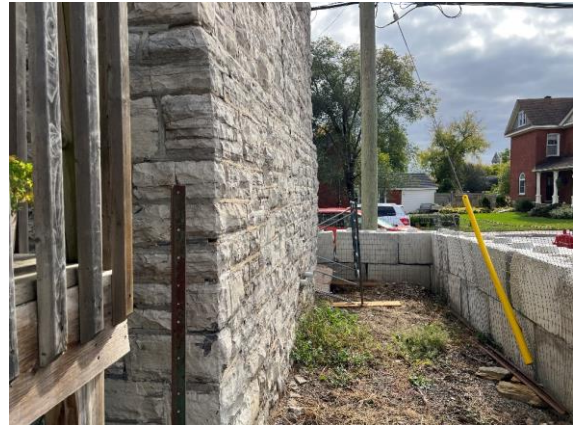
Photo 6: Significant Bow in Exterior Wythe

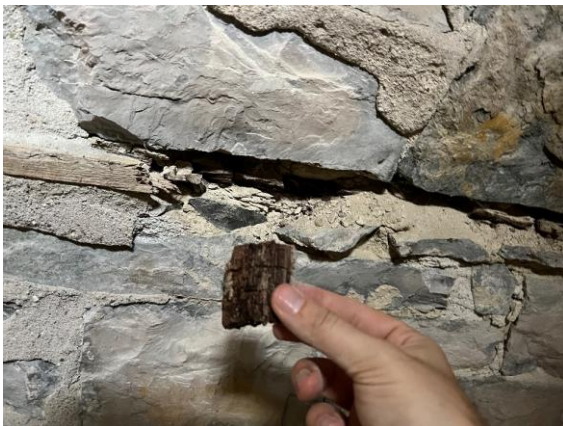
In the interior of the Belltower was exhibiting signs of moisture ingress in the form a rotting wood nailers (Refer to Photo 7). Cracked or missing joints in the interior wythe of the upper most portion of the Belltower was observed (Refer to Photos 8 and 9). At the top of the southeast corner of the Belltower, joints contained voids and stone units appear to have translated. (Refer to Photo 10).

Photo 7: Rotting Wood Nailer in Belltower

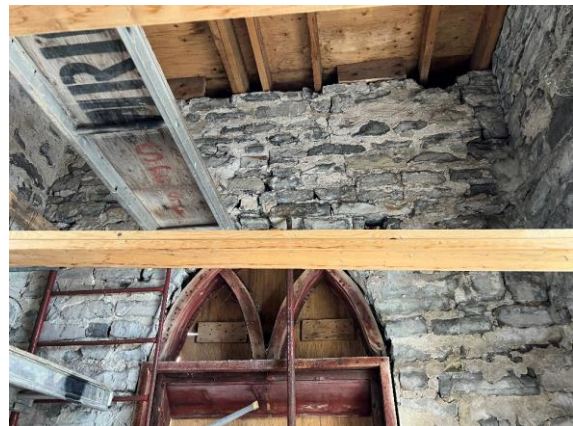
Photo 8: Overall Interior of Belltower

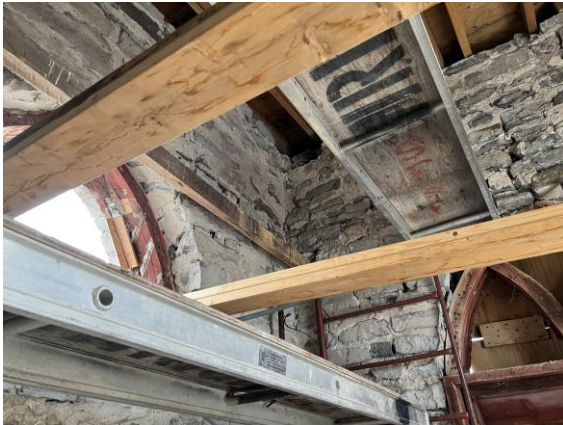
Photo 9: Interior Condition of Southeast Corner

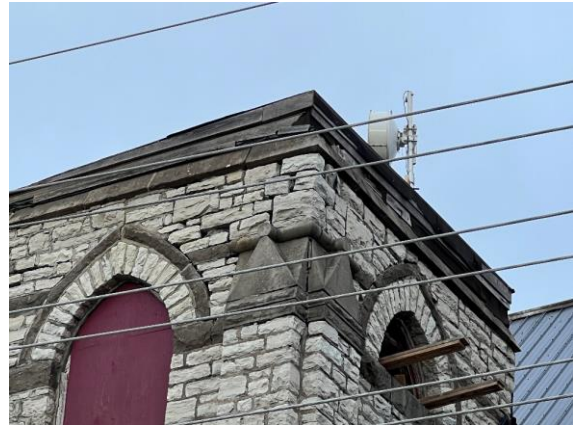
Photo 10: Southeast Corner in Poor Condition

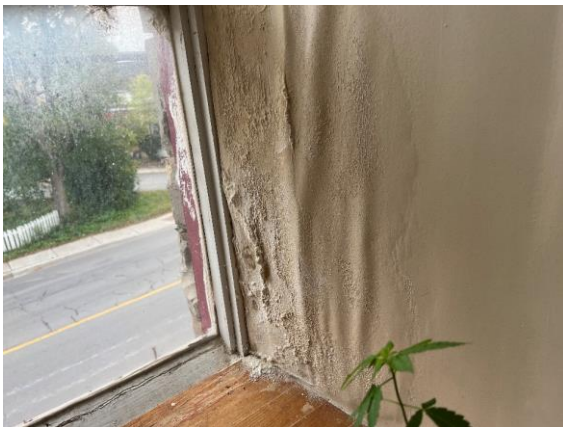
The interior windows jambs showed signs of moisture damage and cracking in the interior finishes (Refer to Photos 11, 12 and 13). Localized water staining was noted in roof. Natural light was observed through the roof structure (Refer to Photo 14).

Photo 11: Moisture Damage

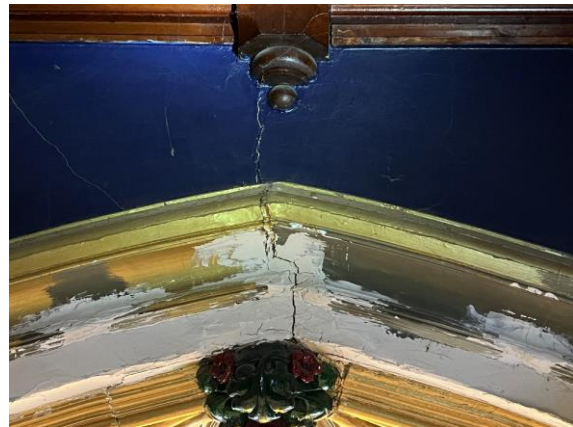
Photo 12: Cracking in East Wall Plaster Finish above Nave

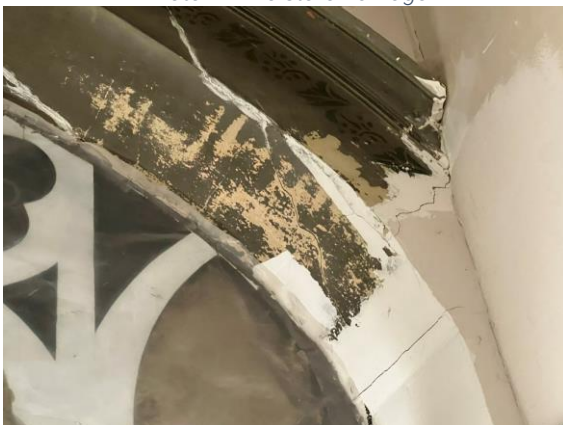
Photo 13: Cracking in Plaster Finish at Window

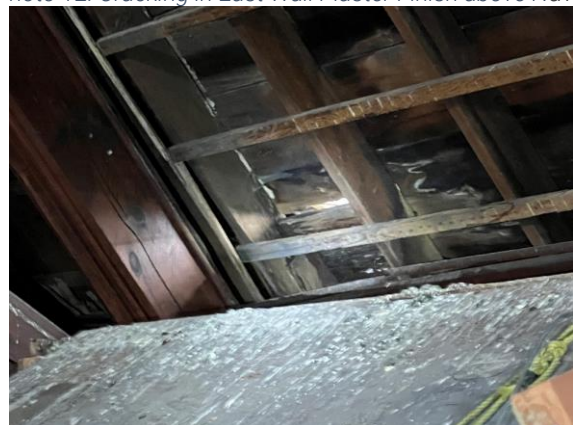
Photo 14: Water Staining and Natural Light

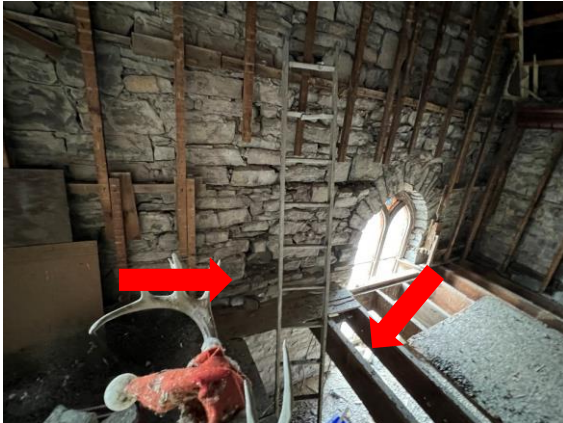
Interior attic west wall was observed to be in poor condition with displaced stones (*Refer to Photos 15 and 16*). Several stones were noted to be on the ceiling of the common space below.

Photo 15: West Wall in Poor Condition with Voids and Stone on Ceiling Below

intervention. The interior wythe has displaced stones, voids in joints, and stone units laying on the ceiling of the common space below. The exterior wythe contains voids in joints. If left unattended, deterioration is expected to continue at an accelerated rate.

At the interior wythe of the west wall in the attic, it is recommended that immediate repairs be undertaken to stabilize the interior wythe and to ensure that stones do not pass through the ceiling and into the common space below. Should immediate repairs not be undertaken, the closure of the common area is recommended to keep safe the public. This will block egress to the tenant spaces beyond, requiring that tenants vacate this end of the building.

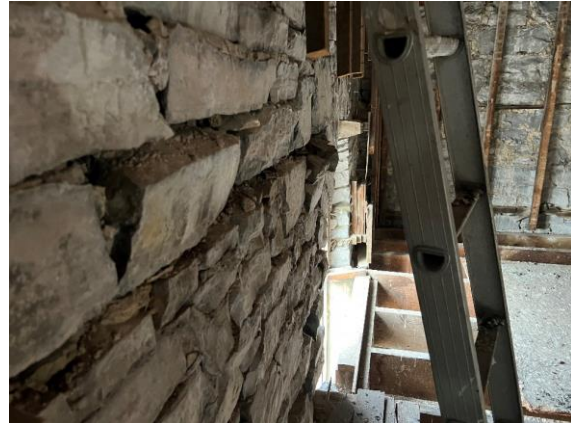
Photo 16: Displaced Stone in West Wall

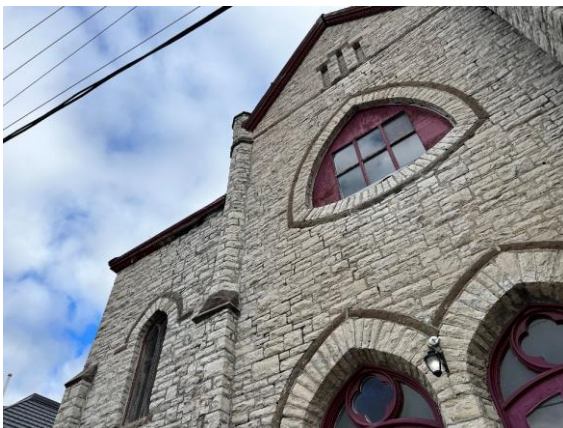
Exterior west wall and south wall were in various stages of condition. Overall the walls were in poor condition. Localized voids in mortar joints were noted throughout. (*Refer to Photos 17 and 18*).

Photo 17: Localized Voids in Mortar joints in West Wall

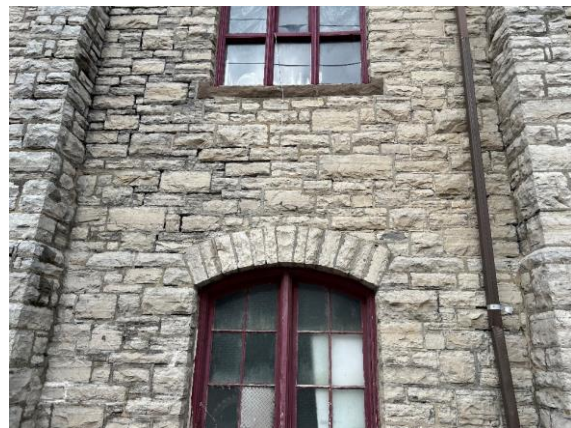
Photo 18: Localized Voids in Mortar joints in South Wall

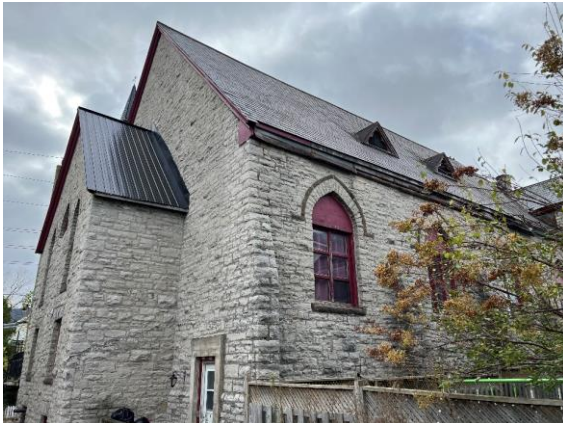
Around the perimeter of the building, eavestroughs were noted to be in poor condition or missing (*Refer to Photo 19*). On the North wall, voids in masonry joints were noted along with a localized missing stone unit (*Refer to Photo 20*). A stone unit was observed to be on grade. In several areas, the North wall exterior masonry joints may be raked by hand (*Refer to Photo 21*). The East wall exterior appeared to be well pointed throughout. (*Refer to Photo 22*).

Photo 19: Missing Eavestroughs

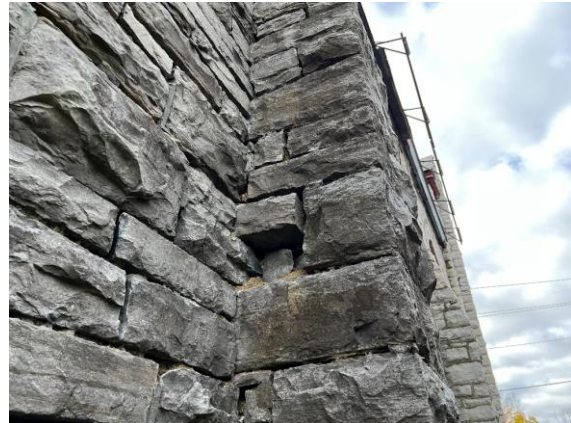
Photo 20: Missing Stone Unit in Buttress

A risk of falling stone was observed in North Wall and requires immediate intervention. At the North exterior wall, a stone unit was observed to be on grade. It is unknown if this was done purposefully or not. The joints are locally in very poor condition. This area may be closed off to public access without serious intervention, and is recommended until further repair may be completed. Regular monitoring reports will advise the future actions required to keep safe the property and public.

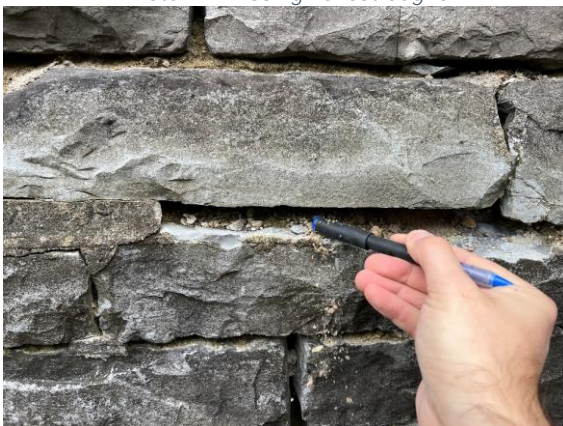
Photo 21: Joint being Raked with a Pen

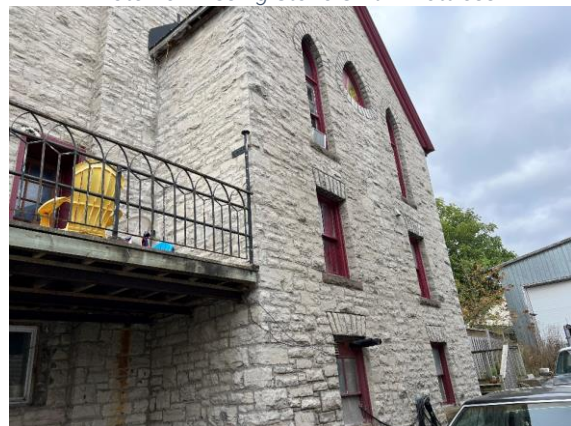
Photo 22: Representative Pointing on the East End
